## Boiler Penetration Seals

# Boiler Penetration Seal Design Considerations

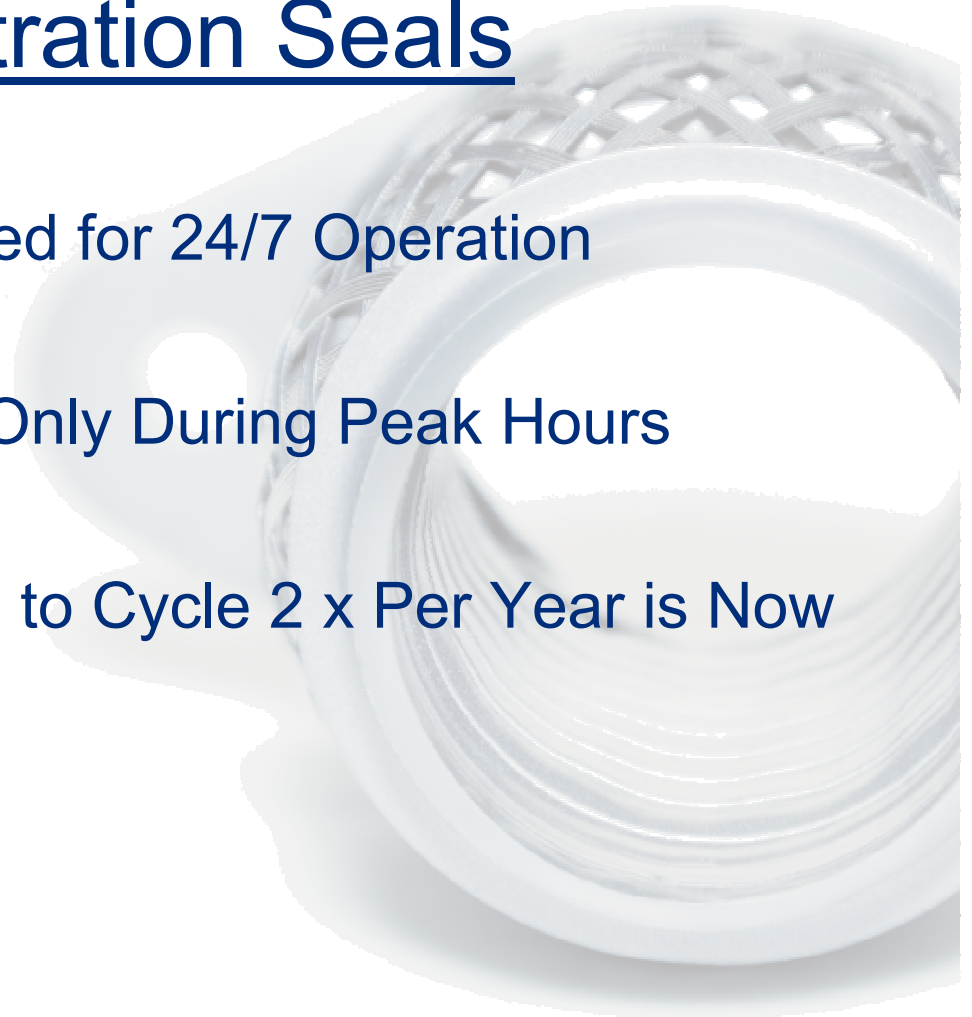
- Current Plants are Designed for 24/7 Operation
- Typical Usage is Actually Only During Peak Hours
- Result is a Plant Designed to Cycle 2 x Per Year is Now Cycling Daily

- Customer misuse of the plant is causing premature failure of the expansion joints due to cycling fatigue.
- Wash down chemicals create a highly acidic condition on the interior surface of the bellows. The thin gauge material prematurely corrodes.

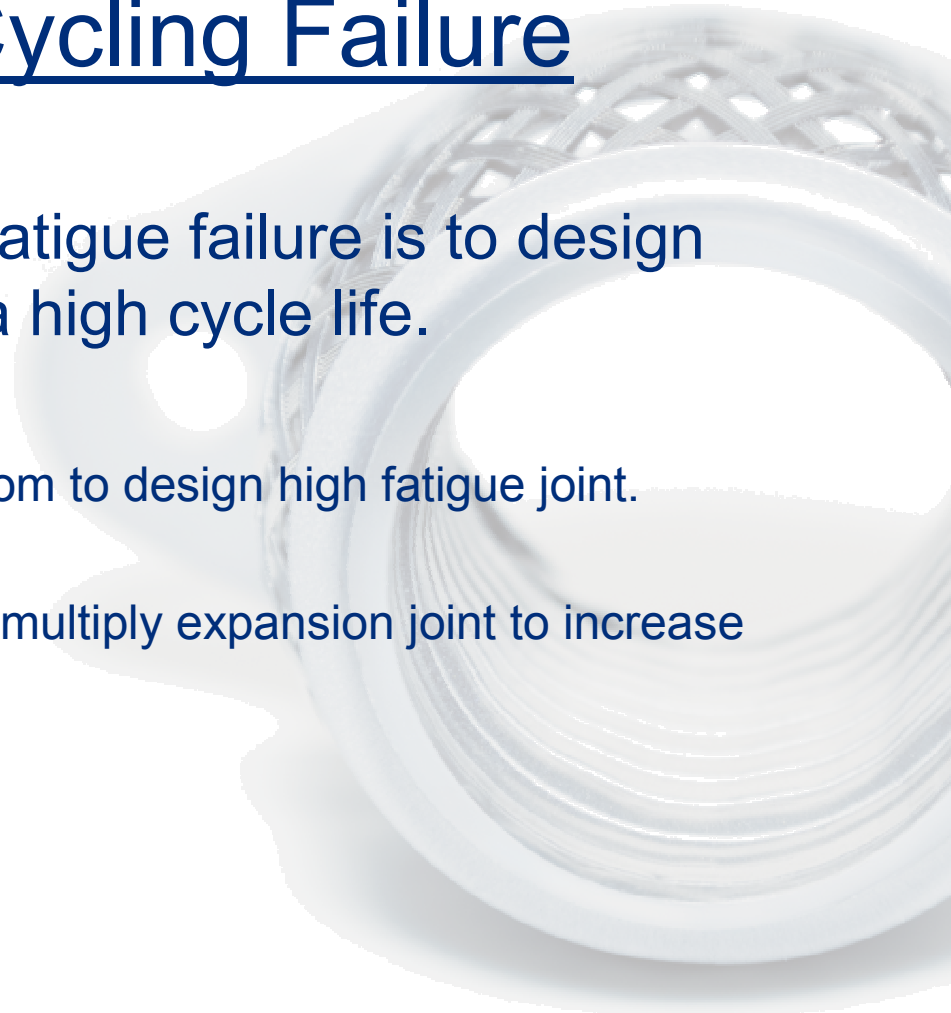
- Best Solution to cycling fatigue failure is to design the expansion joints for a high cycle life.
  - Problem : Not enough room to design high fatigue joint.
  - BOA's Solution: Utilize a multiply expansion joint to increase fatigue life in less space.

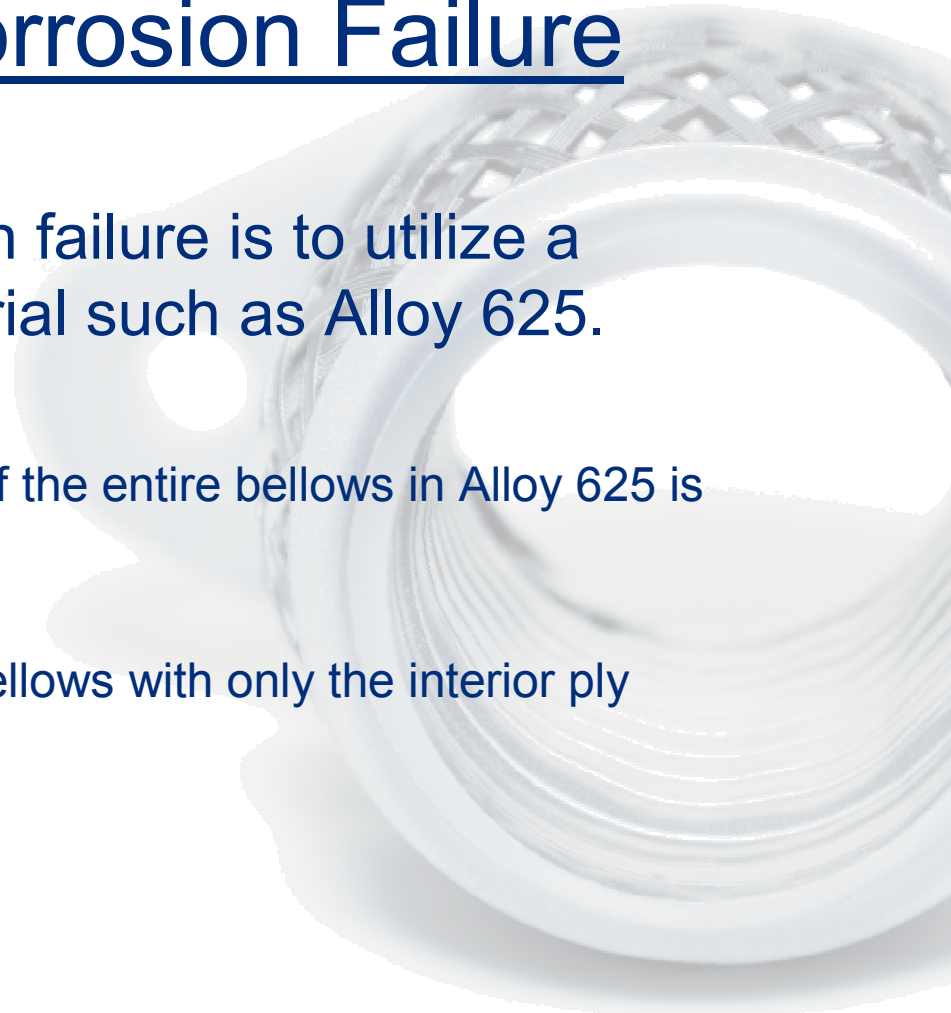
- Best solution to corrosion failure is to utilize a corrosion resistant material such as Alloy 625.
  - Problem : Construction of the entire bellows in Alloy 625 is expensive.
  - BOA's Solution: Use a bellows with only the interior ply constructed of Alloy 625.
